SAFETY ALERT BULLETIN

ACCIDENT REDUCTION PROGRAM

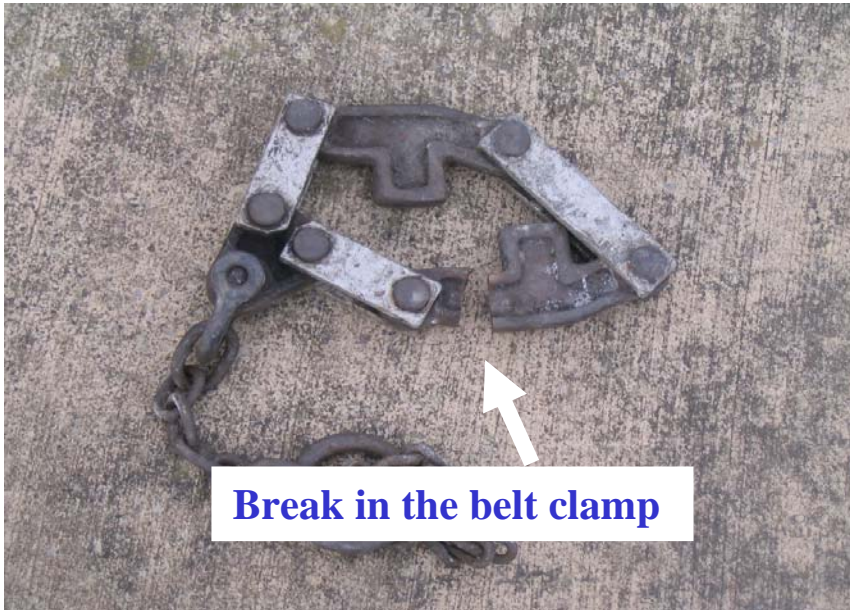
On December 13, 2005, at about 2:00 pm, a crew was repairing a conveyor belt splice on the bottom belt. A 25 year-old employee was on top of the bottom belt preparing to insert the belt pin as the belt was ratcheted together. A 50 year-old employee was ratcheting the belt together when the belt clamp broke and struck the 50 year-old employee in the head causing slight injuries to the head and bruising of the eyes. The 25 year-old employee was pulled back under the top belt and had trouble breathing until he was extricated from the belt. Fortunately, neither employee suffered serious injuries.

Employees should not be on the top of belt being spliced.

Mine personnel ratcheting belt together should not stand in direct line of the belt ropes or clamps during the ratcheting operation.
